DAM INSPECTION CHECKLIST
Department of Environmental Protection
Bureau of Waterways Engineering
Division of Dam Safety

NAME OF DAM: WALKER LAKE DAM

DEP DAM NO.: D52-127

DATE OF INSPECTION: 10/23/2023

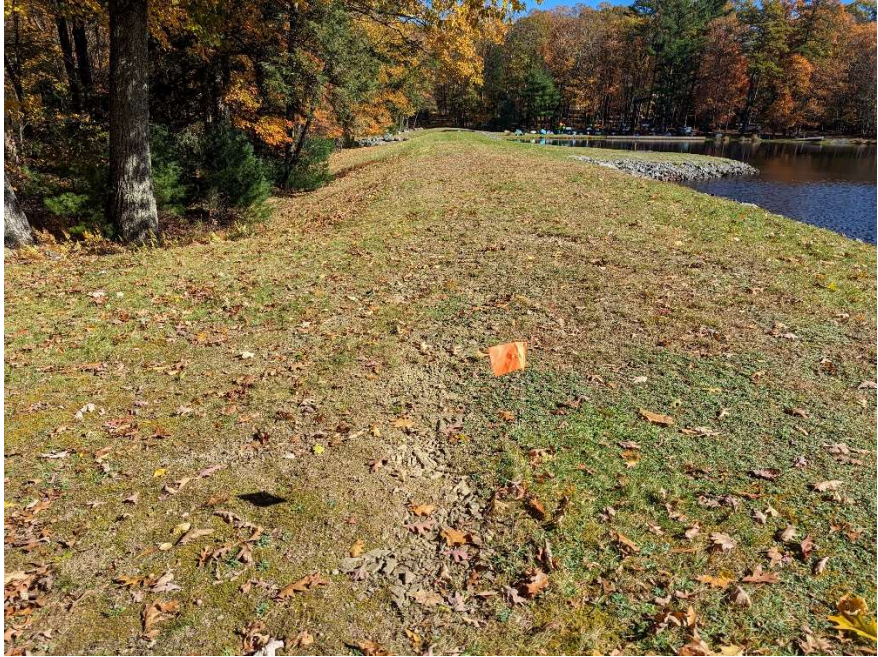
PHOTO #3

#6- GRASS MOWED; REPEAT: RESTABLISH GRASS ALONG L. & R. CREST (PHOTO #3,25)

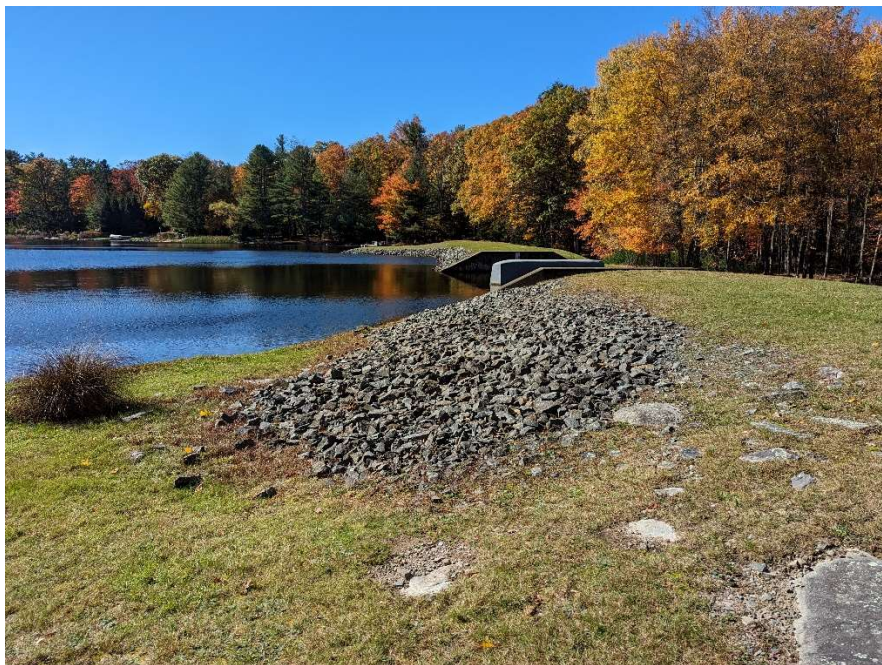
PHOTO #4

#11—RIP-RAP IN GENERALLY GOOD CONDITION (PHOTO #4-6), REPLACE DISPLACED RIPRAP (PHOTO #26)

#15—REPEAT: REMOVE WEED OUTGROWTH IN R&L-SIDE RIP-RAP (PHOTO #4,5)

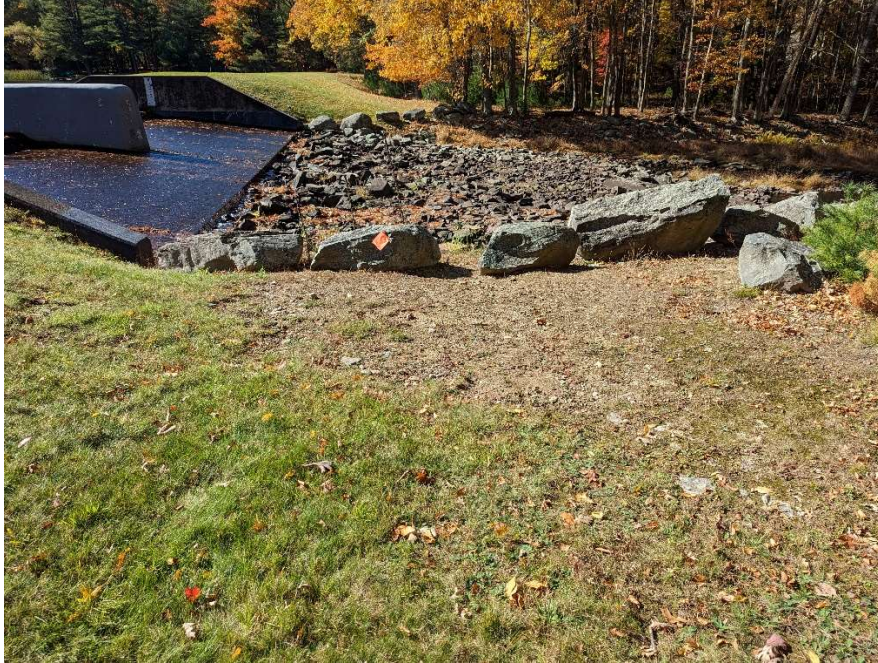
PHOTO #7

#25 – REPEAT: R.SIDE: RESTABLISH GRASS ALONG R. TOE (PHOTO #7); L. SIDE: REMOVE VEGETATION (INCULING SMALL PINE TREES) FROM RIP-RAP OVER DISCHARGE PIPE, ALONG L. TOE (PHOTO #8-10), REMOVE HEAVY LEAF LITTER HINDERING INSPECTION.

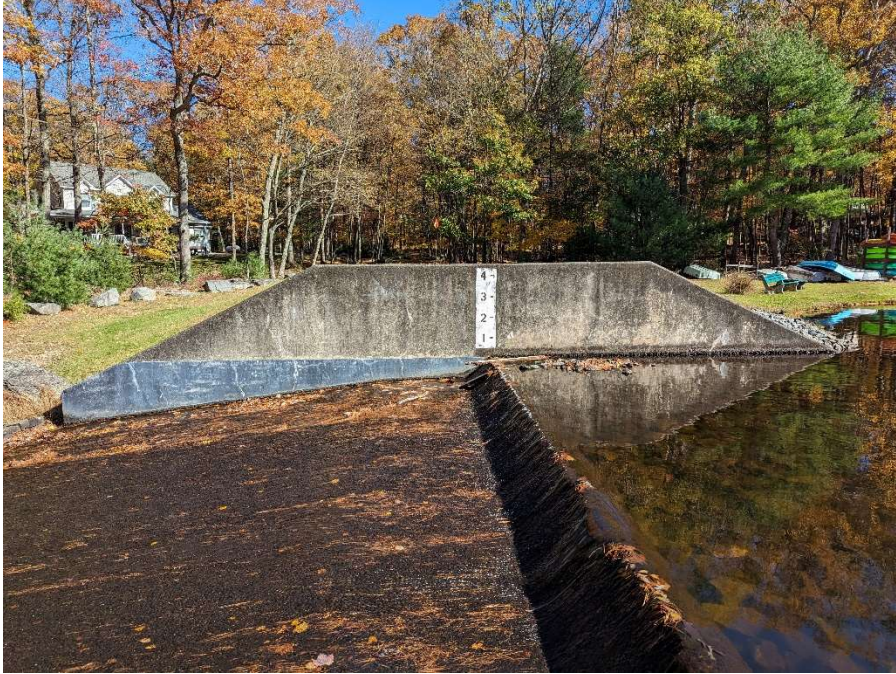
PHOTO #11

28	Piezometers/Observ. Wells	NONE	<input type="checkbox"/>	<input type="checkbox"/>	<input type="checkbox"/>
29	Staff Gauge and Recorder	GOOD CONDITION (PHOTO # 11,12)	<input type="checkbox"/>	<input type="checkbox"/>	<input type="checkbox"/>
30	Weirs	NONE	<input type="checkbox"/>	<input type="checkbox"/>	<input type="checkbox"/>
31	Survey Monuments	NONE	<input type="checkbox"/>	<input type="checkbox"/>	<input type="checkbox"/>
32	Drains	NONE	<input type="checkbox"/>	<input type="checkbox"/>	<input type="checkbox"/>
33	Low Flow Release	NONE	<input type="checkbox"/>	<input type="checkbox"/>	<input type="checkbox"/>
34	Frequency of Readings	NONE	<input type="checkbox"/>	<input type="checkbox"/>	<input type="checkbox"/>
35	Location of Records	NONE	<input type="checkbox"/>	<input type="checkbox"/>	<input type="checkbox"/>
36			<input type="checkbox"/>	<input type="checkbox"/>	<input type="checkbox"/>

#56: WALLS IN GENERALLY GOOD CONDITON; MINOR CRACKS IN EAST & WEST SIDEWALLS (PHOTO #11,12); CENTER DIVIDER WALLS GOOD CONDITION W/ MINOR CRACKS (PHOTO #16,17).
 #57: CLEAR DEBRIS ON R-SIDE (PHOTO #18,19); REPAIR SPALLED CONCRETE IN JOINT (PHOTO #20)
 #60: WEIRS IN GENERALLY GOOD CONDITION (PHOTO #16-19)

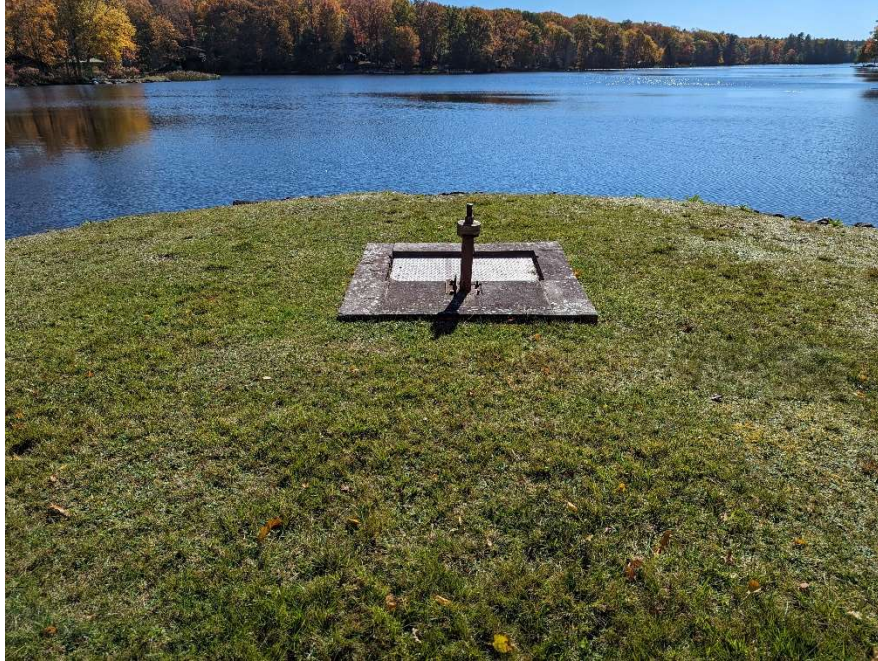
PHOTO #13

46	Security Devices	HANDWHEEL REMOVED; COVER ON CHAMBER (PHOTO #13)	<input type="checkbox"/>	<input type="checkbox"/>	<input type="checkbox"/>
47	Act 91 Run-of-the-River Signs or Bouys	N/A	<input type="checkbox"/>	<input type="checkbox"/>	<input type="checkbox"/>
48			<input type="checkbox"/>	<input type="checkbox"/>	<input type="checkbox"/>
49			<input type="checkbox"/>	<input type="checkbox"/>	<input type="checkbox"/>

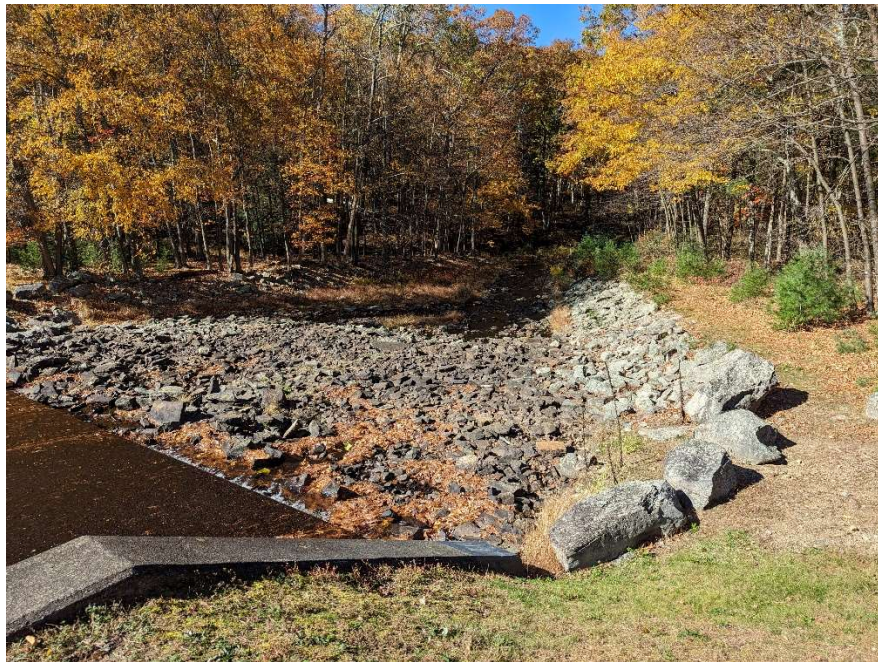
PHOTO #14

#52 – MAIN CHANNEL: GOOD CONDITION (PHOTO #14); DRAWDOWN CHANNEL: REMOVE VEGETATION (PHOTO #15)

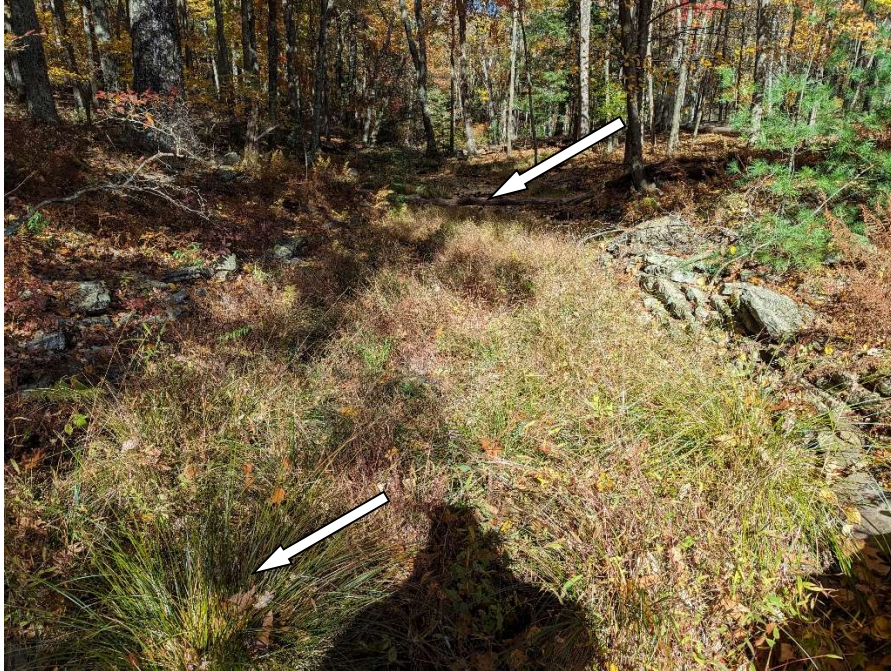
#53 – DRAWDOWN CHANNEL: REMOVE FALLEN TREE (PHOTO #15)

PHOTO #15 (Arrows show vegetation and debris)

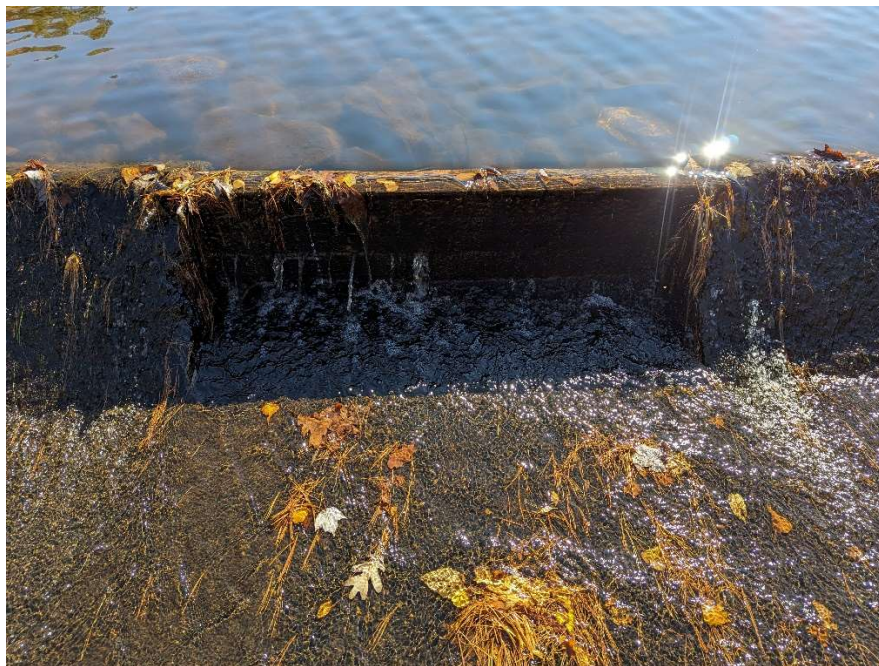
PHOTO #22

#74: REPAIR LEAKING STOP LOG STRUCTURE IN WEIR (PHOTO #22)
 #76, 79: PIPE REQUIRES REPLACEMENT (PHOTO #23). PREVIOUS INSPECTIONS REVEALED SEEPAGE BETWEEN CMP PIPE & CONCRETE SURROUNDING THE PIPE; WATER AT INVERT DURING INSPECTION.

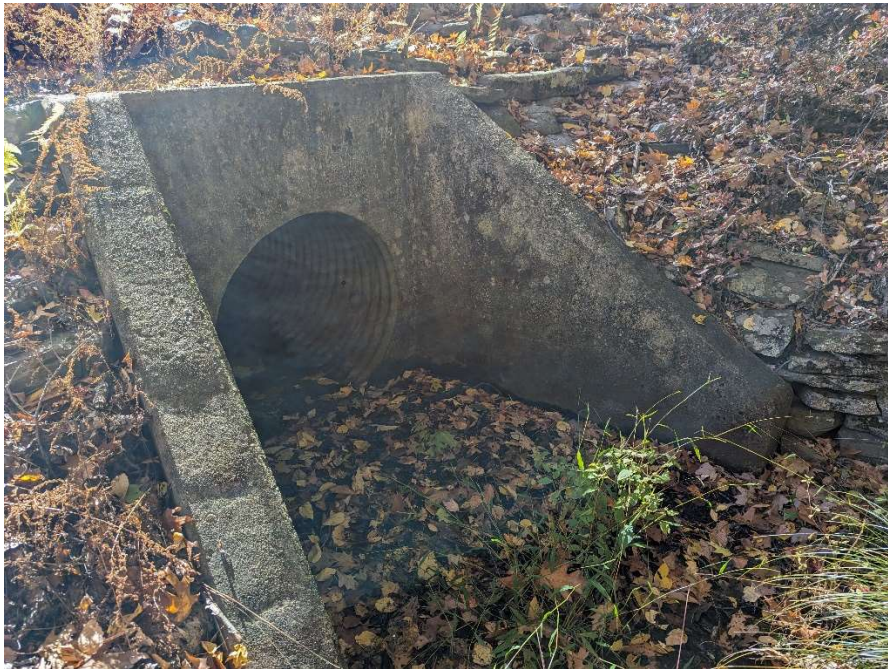
PHOTO #24

78	Outlet Structure	HEADWALL IN GOOD CONDITION (PHOTO #24)	<input type="checkbox"/>	<input type="checkbox"/>	<input type="checkbox"/>
79	Seepage	SEE BELOW	<input type="checkbox"/>	<input type="checkbox"/>	<input checked="" type="checkbox"/>
80	Unusual Movement	NONE APPARENT	<input type="checkbox"/>	<input type="checkbox"/>	<input type="checkbox"/>
81			<input type="checkbox"/>	<input type="checkbox"/>	<input type="checkbox"/>
82			<input type="checkbox"/>	<input type="checkbox"/>	<input type="checkbox"/>
