February 12, 2024

Walker Lake Landowners Association
Shohola Township
Pike County, Pennsylvania

**Re: Walker Lake
Aquatic Macrophyte Survey Final Report for 2023
ALI Project No. 1577-34**

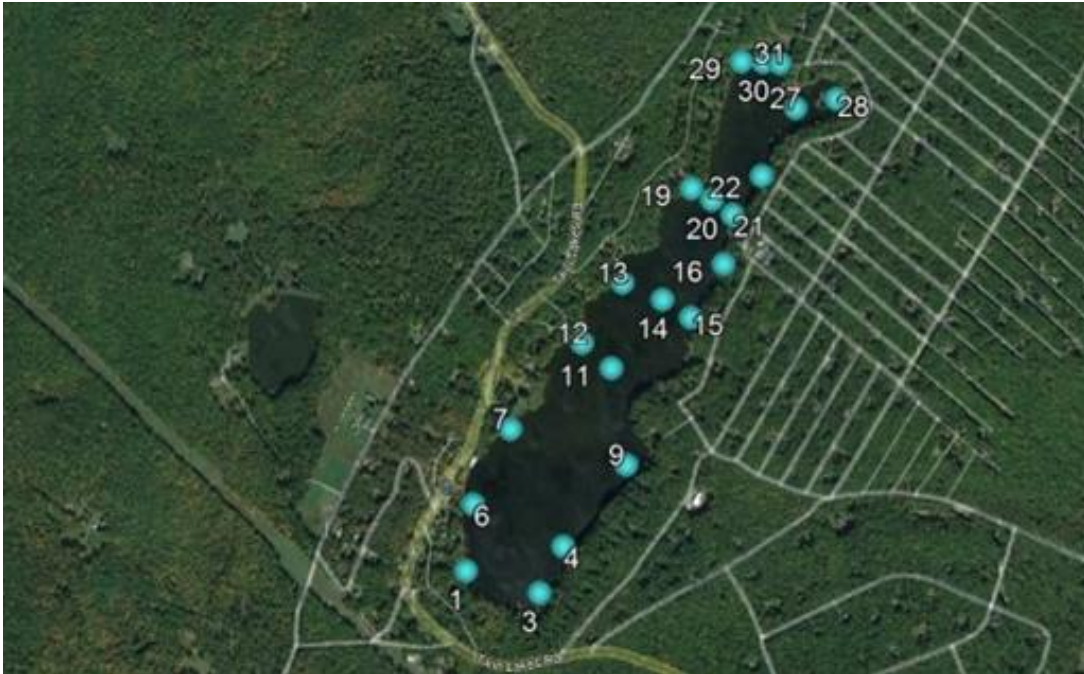
Figure 2 Bladderwort Distribution in Walker Lake in 2022

Results from the 2023 and 2022 aquatic plant surveys are compared to one another in Figures 2 through 7. Figures 2 and 3 depict the distribution of bladderwort in 2022 and 2023, respectively. Figures 4 and 5 present the distribution of floating leaved aquatic vegetation (FAV) in 2022 and 2023, respectively. FAV is the sum of the following plant species: water shield, yellow water lily and white water lily. Lastly, Figures 6 and 7 illustrate the distribution of variable leaf milfoil in 2022 and 2023, respectively. All field data collected during the 2023 aquatic macrophyte survey are summarized in Attachment A. More information about these plant species are presented in Attachment B.

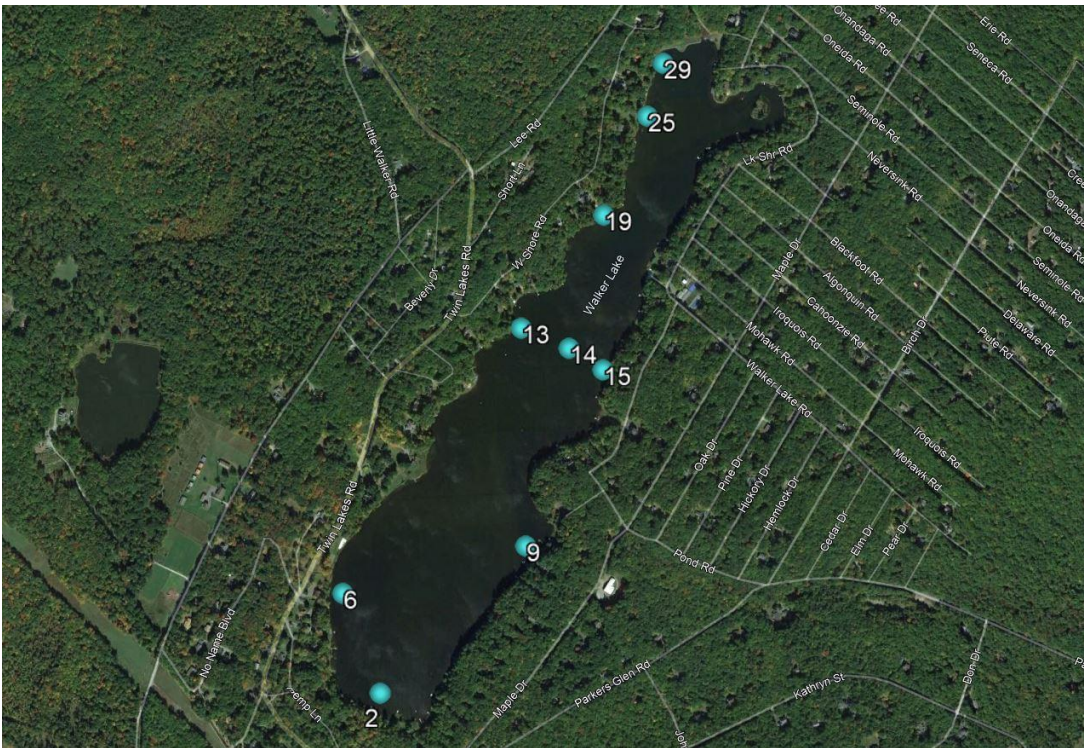
Figure 3 Bladderwort Distribution in Walker Lake in 2023

In 2023, bladderwort was found at 9 of the 31 sampling locations in Walker Lake, making it and stonewort the most prevalent species. Bladderwort was found in low densities with the exception of sample points #9 and #13 where this plant was found in moderate density (Figure 3). For comparison, this plant was found in 21 of the 31 locations in 2022 (Figures 2). Bladderwort is a carnivorous plant common to Pennsylvania. It is most common in the northeast region of the state in water bodies that exhibit an acidic pH (below 7), a low alkalinity (soft water) and cold average water temperatures. Bladderwort is a submerged, free-floating aquatic plant that lacks true roots. Due to this anatomical feature, nutrients are not obtained via the lake sediment, but rather from the water column. Nutrient uptake via the water column is supplemented with captured microorganisms such as zooplankton, insects, and juvenile

crustaceans. Utricles (i.e. small bladders) located at the base of the leaves capture the aforementioned prey. Tiny hair like projections at the opening of the bladder are sensitive to the motion of prey; when stimulated these hairs cause the bladder to suck in water and the passing organism. The bladder is then quickly closed, and the prey is digested.

Bladderwort is a perennial plant that reproduces via seed production, turions (i.e. buds), and fragmentation. A yellow flower protrudes from the water's surface, receives pollen from an insect, then drops a seed. Seeds and turions (buds) lie dormant through the fall and winter season. In the spring, water temperature and sunlight penetration trigger the inflation and subsequent floatation of buds and seeds to the water surface, where a new plant begins to grow. Aside from seeds and buds, fragmentation also results in reproduction. Small leaves, stems, or roots that are broken off begin to sprout and grow into a new plant. Anatomically, bladderwort has finely-divided, branched, submerged leaves, and produces irregular yellow snapdragon-like flowers. Bladderwort provides food and cover for fish. It is especially valuable due to its ability to grow in acidic water bodies with loose sediment where few other aquatic plants will grow.

2. Most of the isolated stands of macrophytes (rooted aquatic plants) found in Walker Lake should be allowed to propagate and spread in 2024. Macrophytes provide habitat for aquatic organisms including fish and compete with phytoplankton (microscopic free-floating algae) for nutrients. Therefore, it is expected that increased quantities of macrophytes will further improve the water clarity of Walker Lake.
3. Early treatment, mid to late May, is again strongly recommended for bladderwort and variable leaf milfoil control in 2024. A follow-up treatment should occur near the end of June through July, depending on the speed of regrowth, to treat any regrowth or additional locations not targeted in the initial treatment.

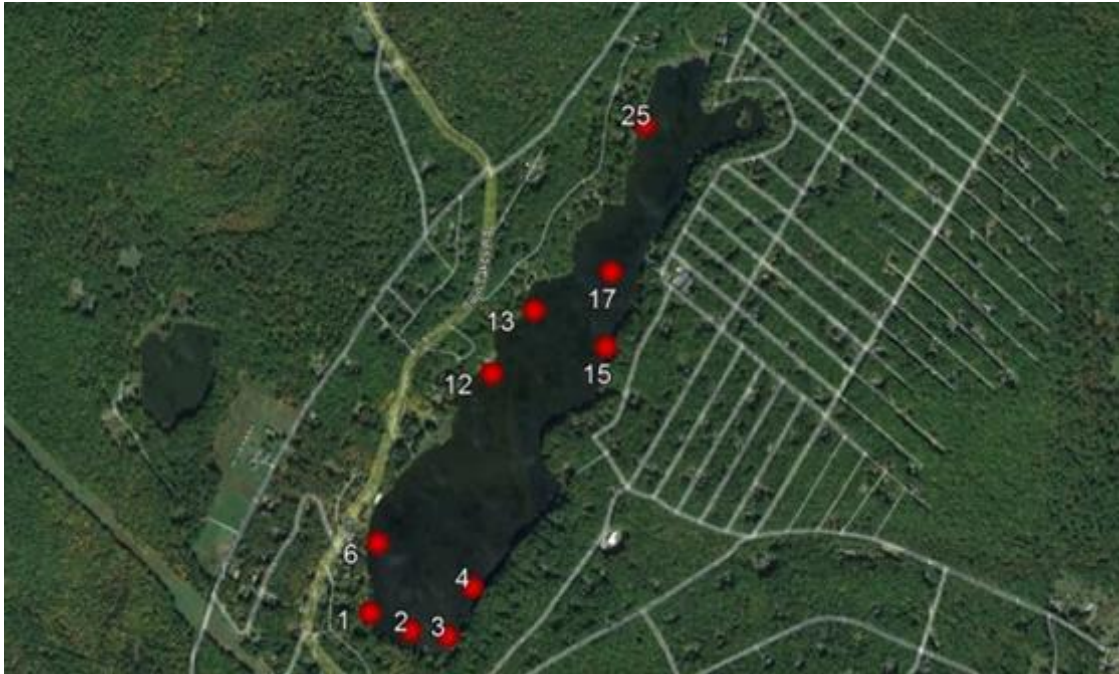
Figure 6 Variable Leaf Watermilfoil Distribution in Walker Lake 2022

Variable leaf milfoil was first discovered with low density at 1 location during the 2020 survey. Variable leaf milfoil was once again observed during the spring of 2021 macrophyte survey at one location. While Aqua Link performed a fishery survey of Walker Lake on November 11, 2021, the spread of variable leaf milfoil in several different locations throughout the lake in low to moderate densities was observed. As noted previously, this non-native invasive plant was only observed at 1 monitoring station during the 2021 aquatic plant survey. This non-native, invasive plant was observed at 10 monitoring stations during the 2022 aquatic plant survey compared to only 2 observed at monitoring stations during the 2023 macrophyte survey. Herbicide treatments specifically targeting this species occurred twice in 2023 after this macrophyte survey was conducted. Treatments were successful, but somewhat temporary as the

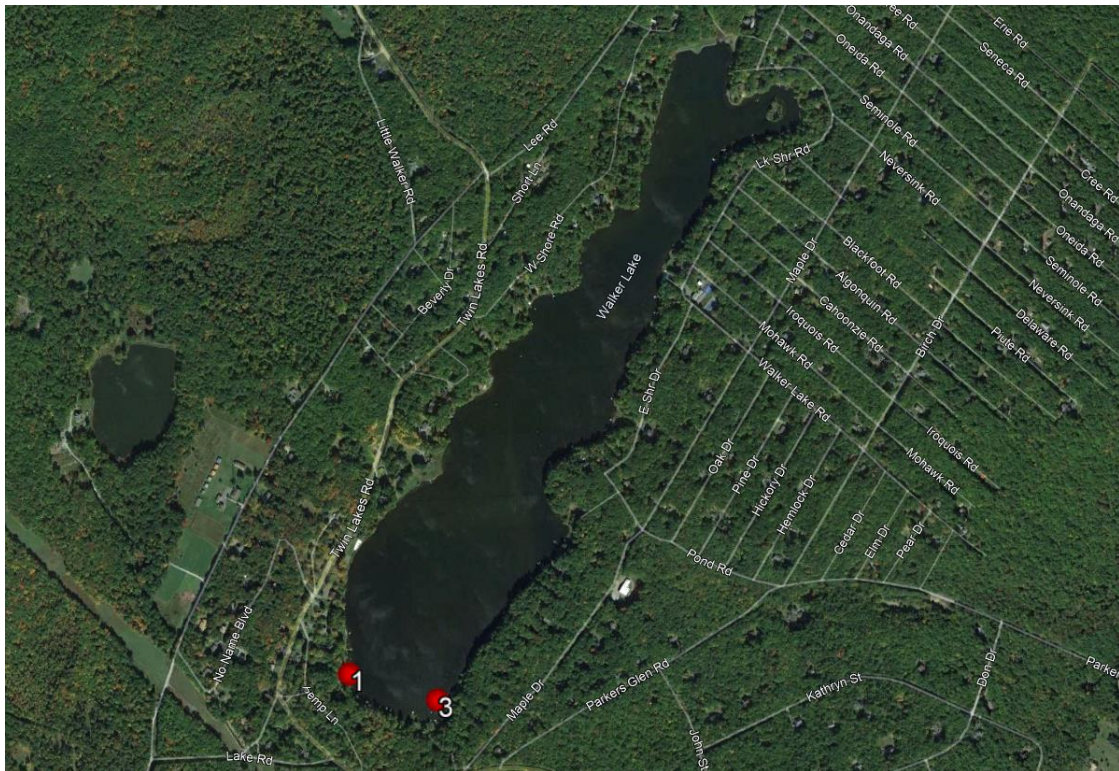
Figure 7 Variable Leaf Watermilfoil Distribution in Walker Lake 2023

Variable leaf milfoil was observed during the 2023 macrophyte survey at 2 locations. This species is a submerged aquatic plant that has feather like leaves whorled around a main stem. The leaves of this plant are highly variable, containing anywhere from 5 to 14 leaflets per leaf and generally there are 4 to 6 leaves per whorl. Stands of this plant can grow to be extremely dense, with stems reaching heights of well over ten feet. Typically this plant flowers in late June to early July and produces white flowers on an emergent bract. Coloration on the plant is green with a brown to reddish hue on leaf tips. This plant can spread quickly as one of its modes of reproduction is through fragmentation in which pieces of the plant break off and form a new plant. Because of this, it can quickly out-compete native, beneficial forms of vegetation and grow in very dense stands. Variable leaf milfoil can grow to be so dense that it can substantially decrease dissolved oxygen levels and make recreational activities nearly impossible. It was likely introduced as an aquatic hitchhiker on boat equipment or by waterfowl. Its re-emergence in 2023 indicates some successful reproduction in previous years and the presence of a viable seed bank that may be fairly significant in size.

herbicide used was an effective contact herbicide. Therefore, some plants will likely continue to regrow in 2024 and beyond. The herbicide was selected due to its effectiveness and lower relative cost. The goal using this type of herbicide for variable leaf milfoil is to treat plants before they produce seed. This, in turn, will allow fewer plants to grow in subsequent years.

1. Any identified stands of variable leaf milfoil should quickly be controlled in Walker Lake in 2024. Variable leaf milfoil, which is a non-native invasive aquatic plant, was identified for the first time in 2020. It should be noted that

A third herbicide treatment is highly recommended during the latter part of the summer to specifically target variable leaf milfoil and prevent the spread and reproduction of this highly invasive plant.
